Tying Research into Practical Solutions

JACOB WISEMAN
Extension Associate
North Carolina State University, Soil Science
919-513-3841
Jacob_wiseman@ncsu.edu

Erosion Control

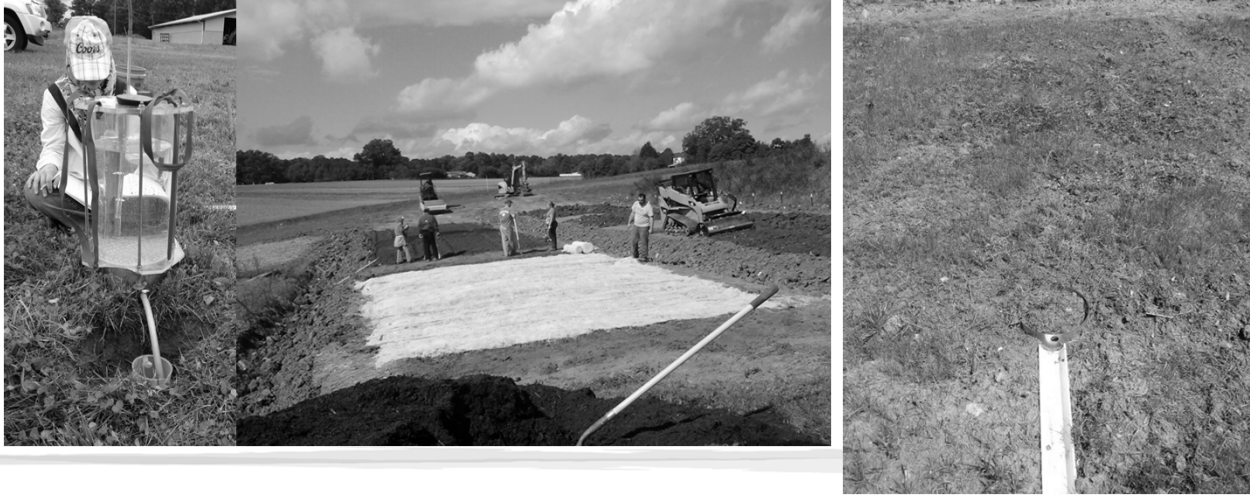
Infiltration Plots and Measurements

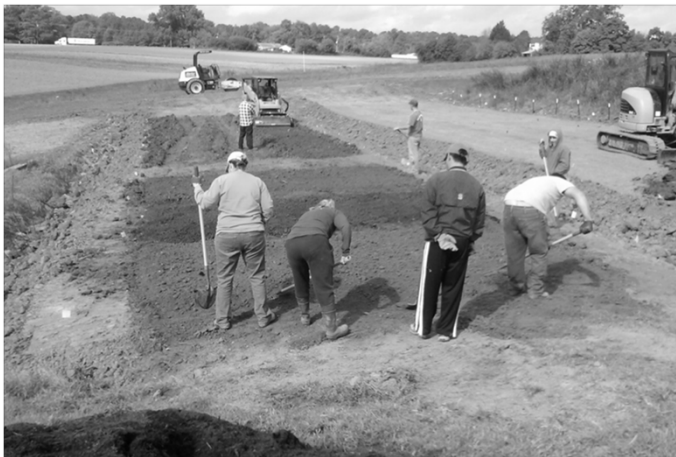
Rooting depths:

Compacted soil, shallow till, and deep till respectively

- Deeper tillage = deeper root penetration = less runoff.

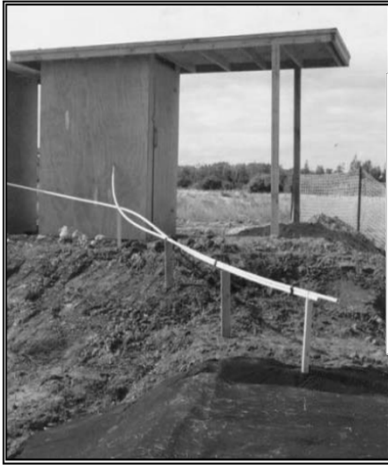
Figure 4. Rainfall Activated Flocculation Housing

New Zealand Rainfall Activated PAM Doser

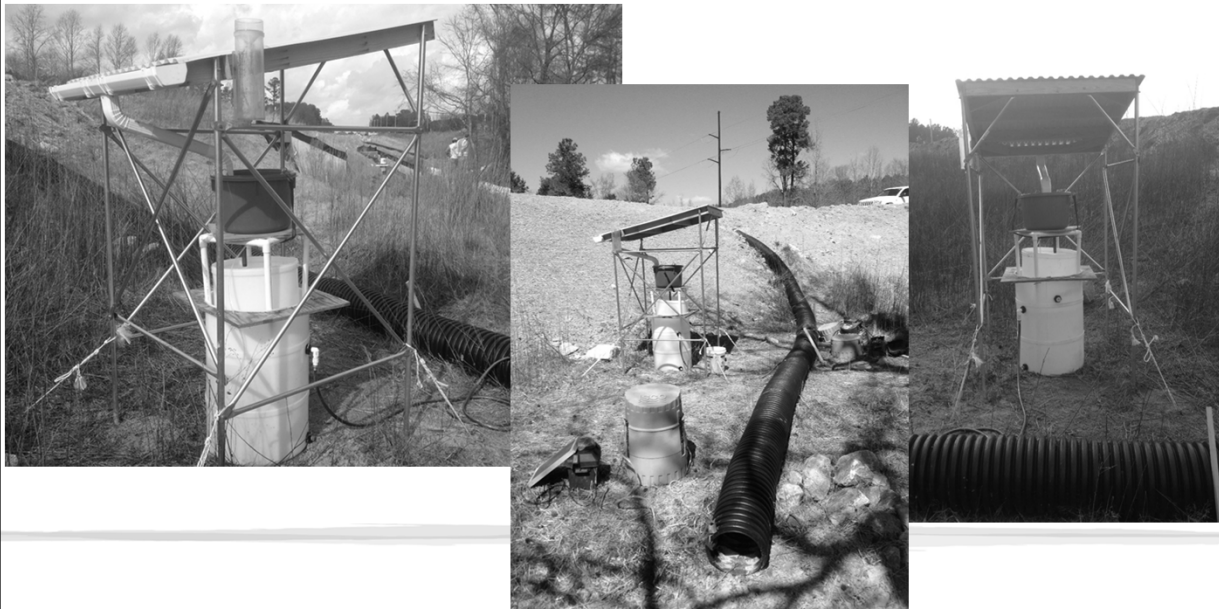
New Zealand Rainfall Activated PAM Doser

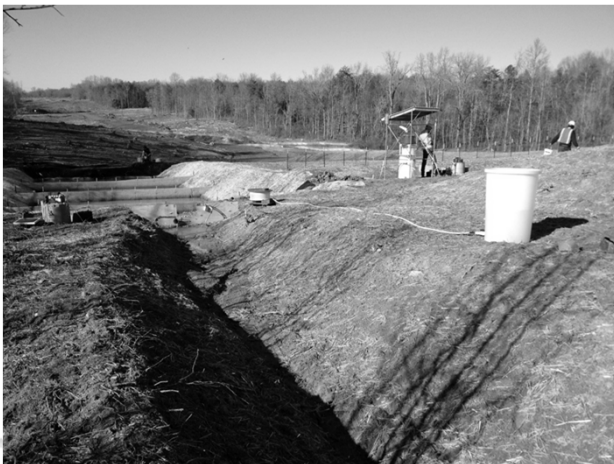
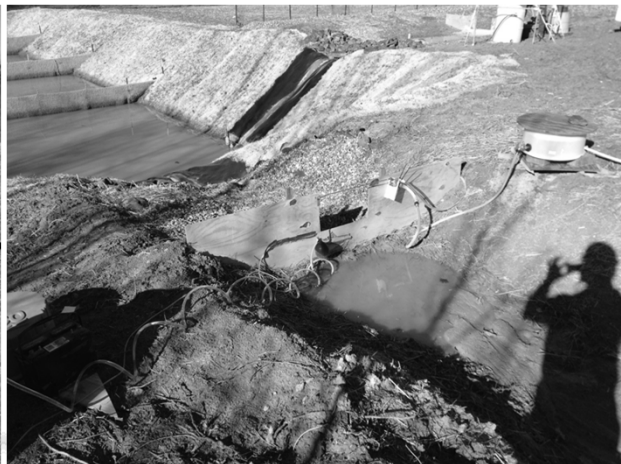
Float Valve Doser

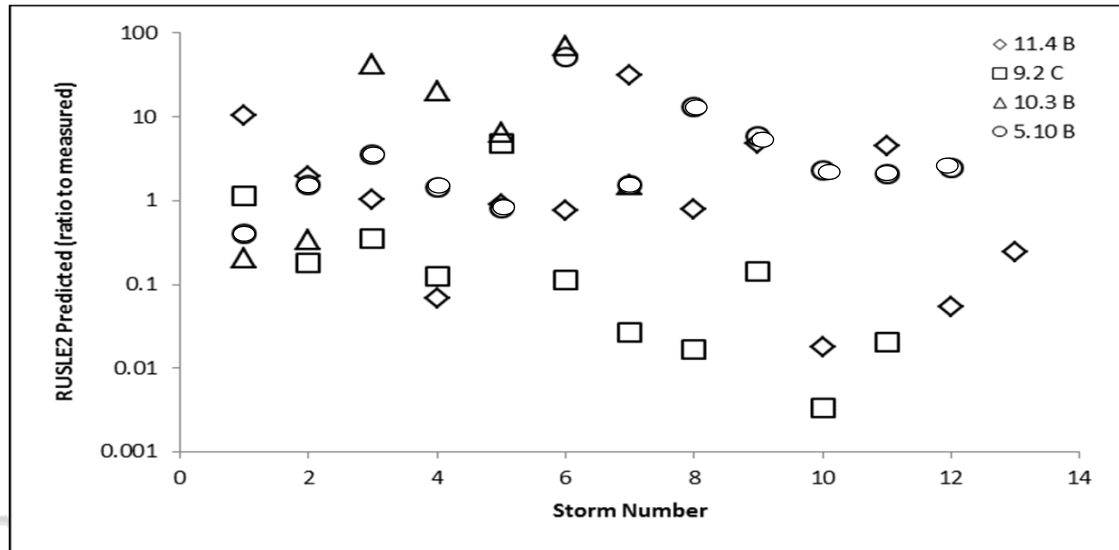
Case Study - Results

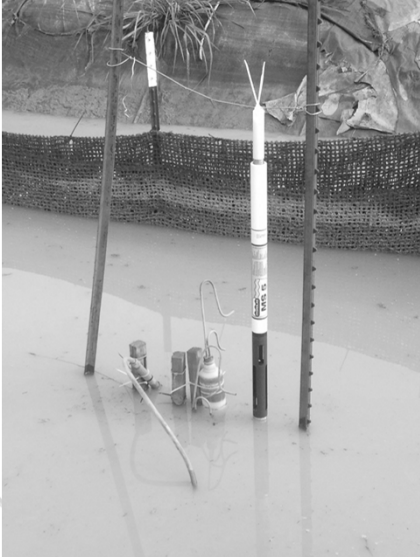
Comparison of Sampling Methods

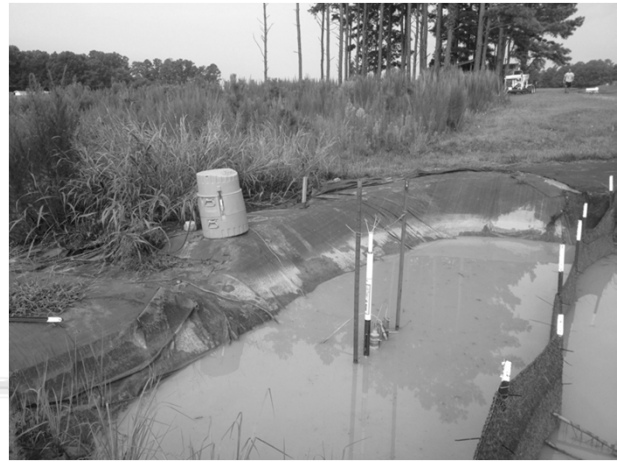
Bottles on a Stick Grab Samples
Automated Sampler Turbidity Sonde
