**WATER  
RESOURCES  
RESEARCH  
INSTITUTE**

## ENGAGING YOUTH IN IMPROVING BURNT MILL CREEK THROUGH HIGH PRIORITY STORMWATER RETROFITS

EPA319 grant Sponsored by NC Division of Water Resources

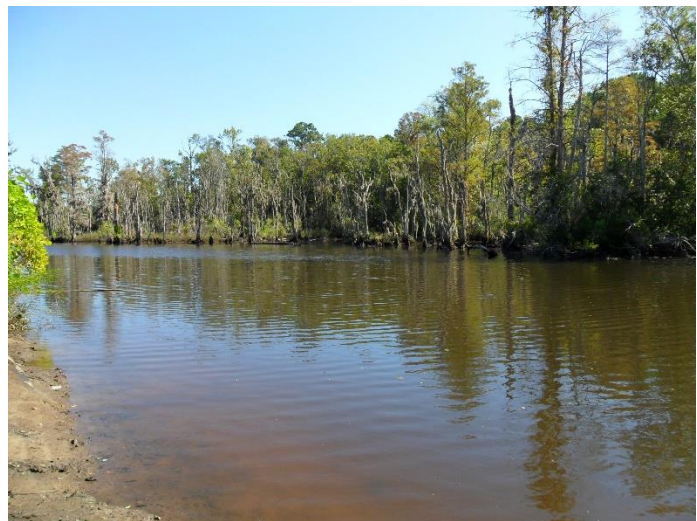
Figure 1: Burnt Mill Creek - lower portion

Burnt Mill Creek, in the lower Cape Fear River Basin, is listed as impaired for aquatic life and secondary recreation on the state's 303(d) list from impacts of urban stormwater runoff, including impacts from Chlorophyll *a*. In 2002, the NC Division of Mitigation Services (formerly NC Ecosystem Enhancement Program) completed a watershed plan for the creek. NC Division of Water Resources' Assessment Report of the Burnt Mill Creek Watershed (2004) identified toxic impacts from polycyclic aromatic hydrocarbons (PAHs) as a primary cause of biological impairment, with secondary and cumulative causes identified as sedimentation and nutrient enrichment. Stakeholders led by NC State University and City of Wilmington have been working together since then to implement watershed improvement projects such as those recommended in the NCDWQ Report:

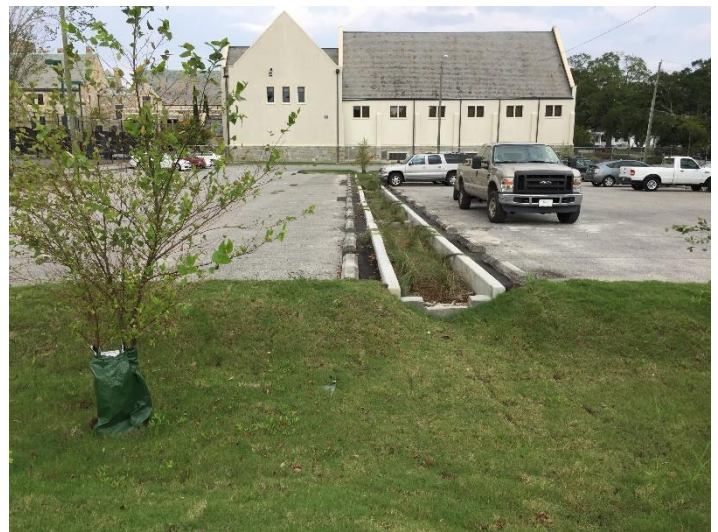
The parking lot was retrofitted with four bioswales and three bioretention cells. Sod was planted in the bioretention cells and muhly grass was planted in the swales. Cape Fear River Watch volunteers installed the plants, which included muhly grass (*muhlenbergia capillaris*) in the bioswales and four river birches (*Betula nigra*) in the bioretention cells. An educational sign was installed.

Figure 2: Bioretention and bioswale at NHHS

**Size of treatment area:** 48,969 square feet of parking lot

**Size of bioretention cells/bioswales:** 2,744 square feet total

**Pollutant removal:** See section of this document entitled: "Summary of Retrofit Monitoring Results" for details. The bioretention/bioswales reduced the runoff coefficient from 0.45 to 0.28, meaning that

before SCM was built, 45% of a rainfall event became runoff, while 28% of a rainfall event became runoff after the SCM was built. Stormwater runoff volumes are reduced by 36%.

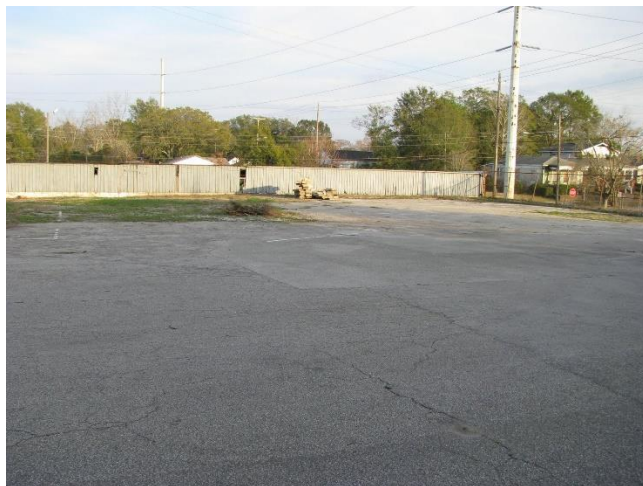
**Figure 3: DREAMS parking lot before retrofit**

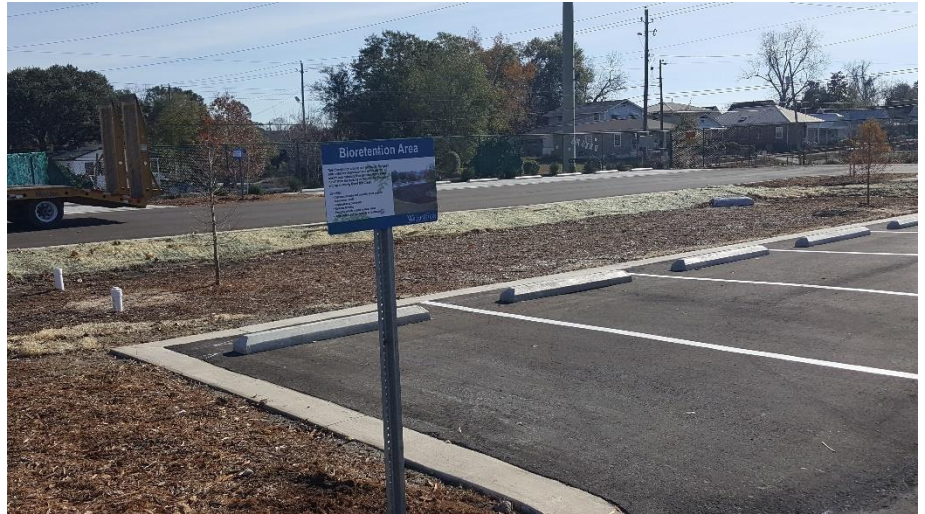
The parking lot was retrofitted with a 2,540 square foot bioretention area in the middle of the parking lot, surrounded by an asphalt driving lane, and 16 permeable paved parking stalls (out of 24 required stalls) that total 2,400 square feet. The permeable pavement and bioretention were sized to detain and treat runoff from the 1.5-inch storm. The City of Wilmington Planning Department required following their parking lot landscaping ordinance, with landscaping areas surrounding the periphery of 3 sides of the parking lot. The bioretention was planted with cypress trees, and the landscaped areas were planted with

Figure 4: DREAMS parking lot bioretention area and sign

**Size of treatment area:** 19,204 square feet of parking lot (reduced by 530 square feet from 19,733)

**Size of bioretention cell:** 2,540 square feet

**Size of permeable pavement:** 2,400 square feet

**Pollutant removal:** The bioretention cell and permeable pavement were designed to capture and treat 1.5" of runoff. The bioretention cell removes 2,400 cu ft of stormwater runoff, while the permeable pavement removes 300 cu ft. of stormwater runoff. The following expected pollutant load reductions were calculated using the Jordan/Falls Lake Stormwater Load Accounting Tool

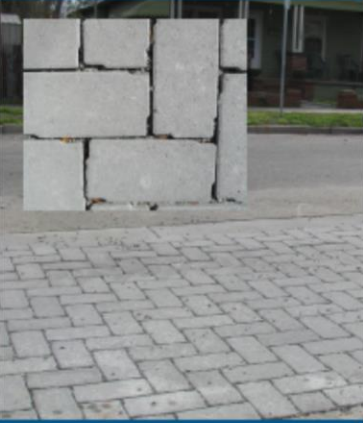
Unlike traditional pavement, **pervious surfaces** allow polluted stormwater runoff to soak into the ground. Pervious surfaces are used for driveways, walkways and parking lots. Pervious surfaces can include pervious concrete, stepping stones, driveway strips and grid pavers like you see in these parking stalls.

Figure 7: DREAMS parking lot permeable pavement sign

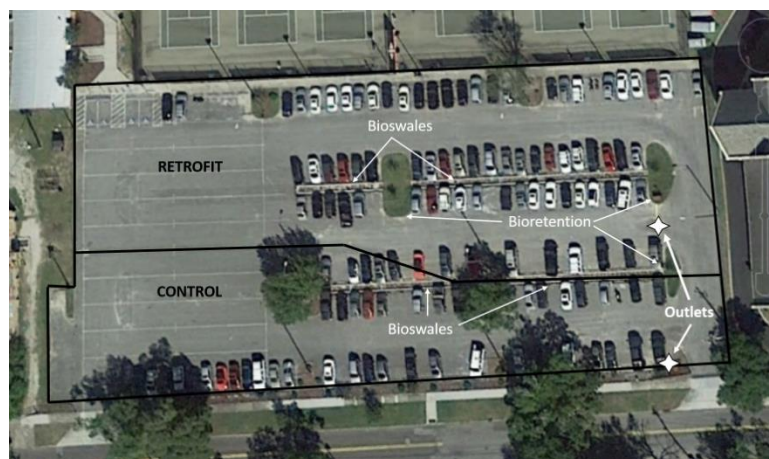
The main challenge with this project was not discovered until the end of the monitoring period. As part of the southern system, two curb cuts were placed in one location to allow runoff to enter from either side. Storms of certain depth and intensity caused ponding within the cell to a height of the inlets. Any additional rain caused runoff to flow from the Retrofit watershed through the inlets and into the Control watershed and catch basin. After observing cross-over occur several times, it was determined that this was a very frequent occurrence. In effect, a new watershed was created during the Treatment period breaking the paired watershed assumptions.

Figure 9: Actual NHHS parking lot monitoring treatment areas, after retrofit

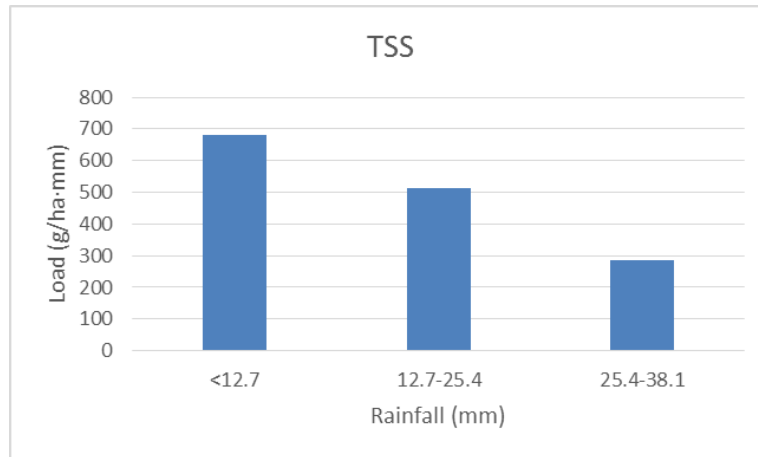
A first flush analysis was also conducted for the parking lot. The pollutant load per millimeter of runoff was compared over several rainfall intervals to determine if the first portions of a storm contain the greatest amounts of pollutants. This analysis showed that for TN, TP, TSS, Cu, and Zn the load per millimeter of runoff was greatest in the first 12.7 mm (.5 inch) of rainfall. The Pb load per millimeter of runoff was greatest in the first 25.4 mm (1 inch) of rainfall. An example of the plot created is below.

Figure 10 First flush analysis for TSS

Future SCM retrofit designers should take the age and condition of a parking lot into consideration. More detailed topographic surveys may be needed to fully characterize existing flow patterns. Sediment may be the pollutant of concern in older lots, so SCM design should focus on sediment capture. Due to the apparent first flush effect, it may be more efficient for retrofit SCMs to be designed to capture the first 12.7 mm (.5 inch) of rainfall.

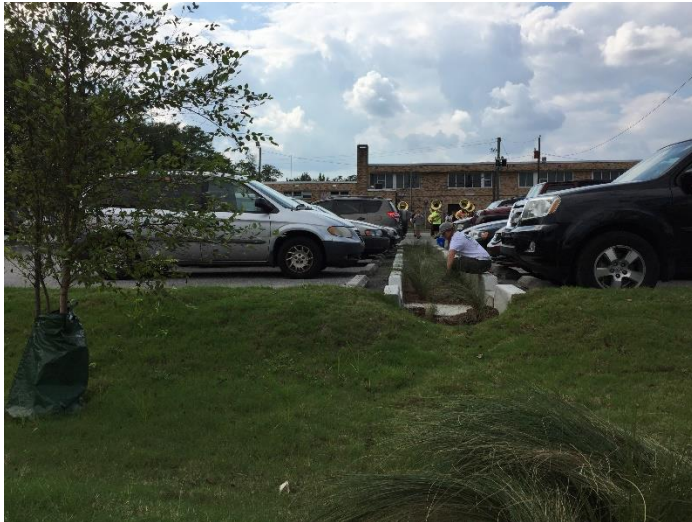
Figure 11 NHHS Bioretention and bioswale

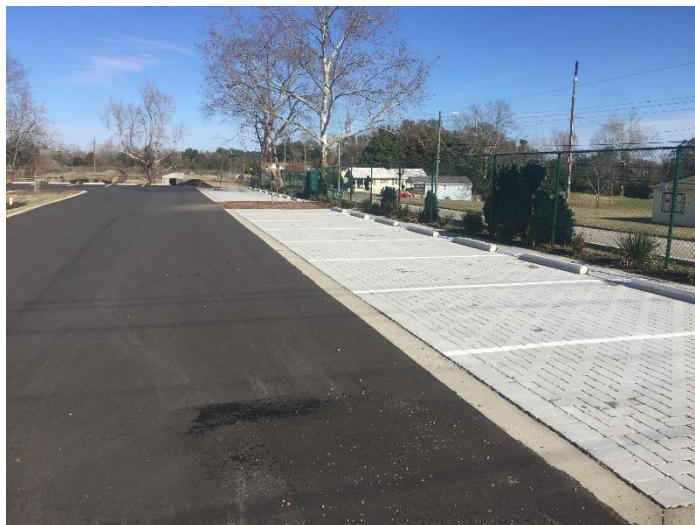
Figure 14 DREAMS parking lot permeable pavement
