Walnut Creek Wetland Park Inventory

Natural Resources Measurements – Spring 2019

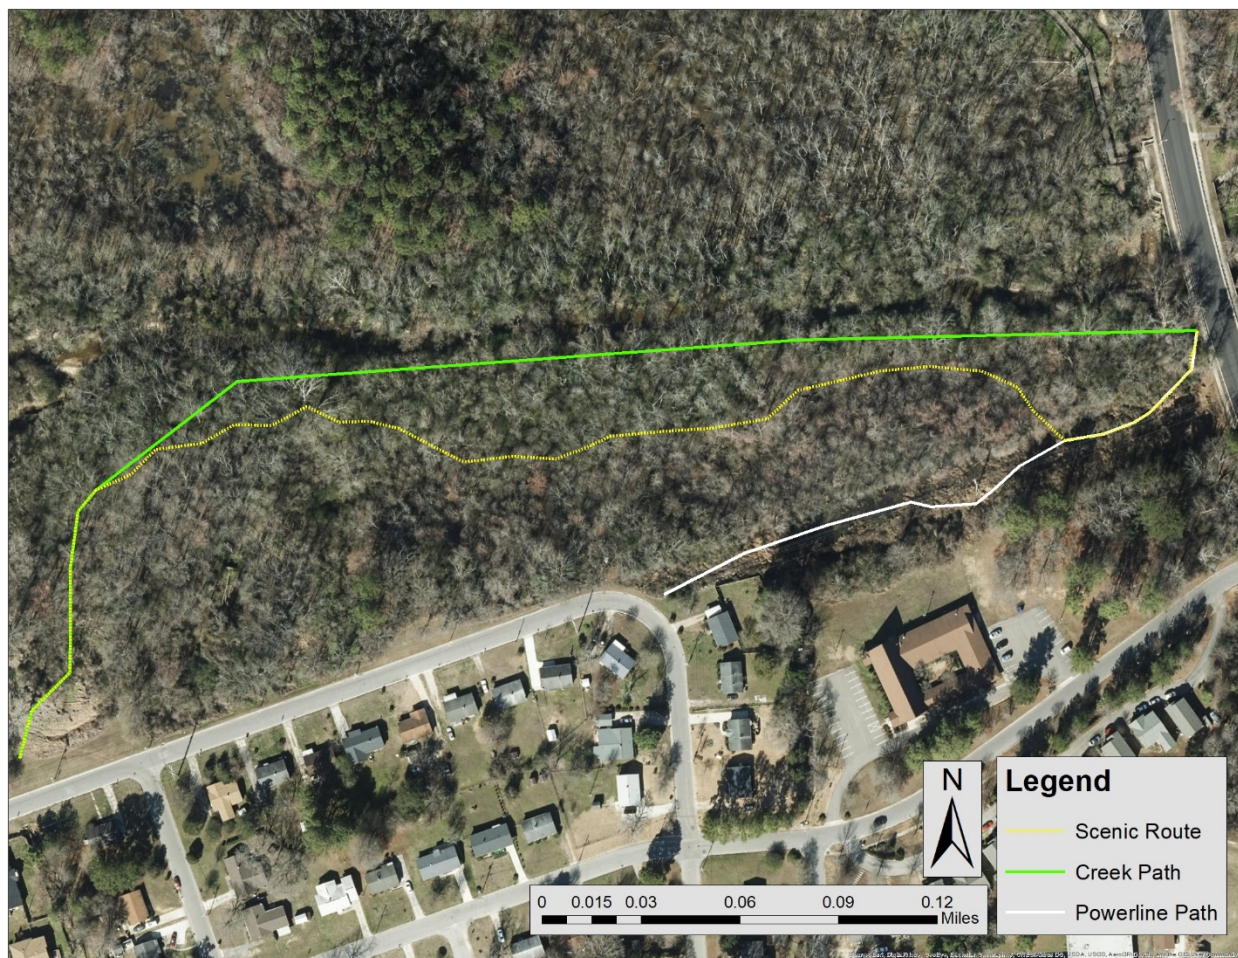
Figure E4. Three proposed pathways to connect the south side of Walnut Creek Wetland Park to the rest of the park and the Walnut Creek Wetland Center.

One of the main development goals noted in the master plan for Walnut Creek Wetland Park is a trail that runs through the southern region of the wetland. The purpose of this trail is to provide a more accessible entrance for the Rochester Heights community to the south of the park. There are many long-term plans in place to make this happen, however, the director of the park would like a simple mulched or similar path to be put in place within the next 1-2 years. We evaluated the moisture levels of the soil and the standing water levels at various locations in the area of study to determine if mulch would be a viable option. Three possible routes were mapped out through the area, with mulch being a possibility for the majority of each (Figure E4). In some areas, however, we are recommending a grounded boardwalk comprised of simple wooden planks to provide some resistance against the flooding that often occurs.

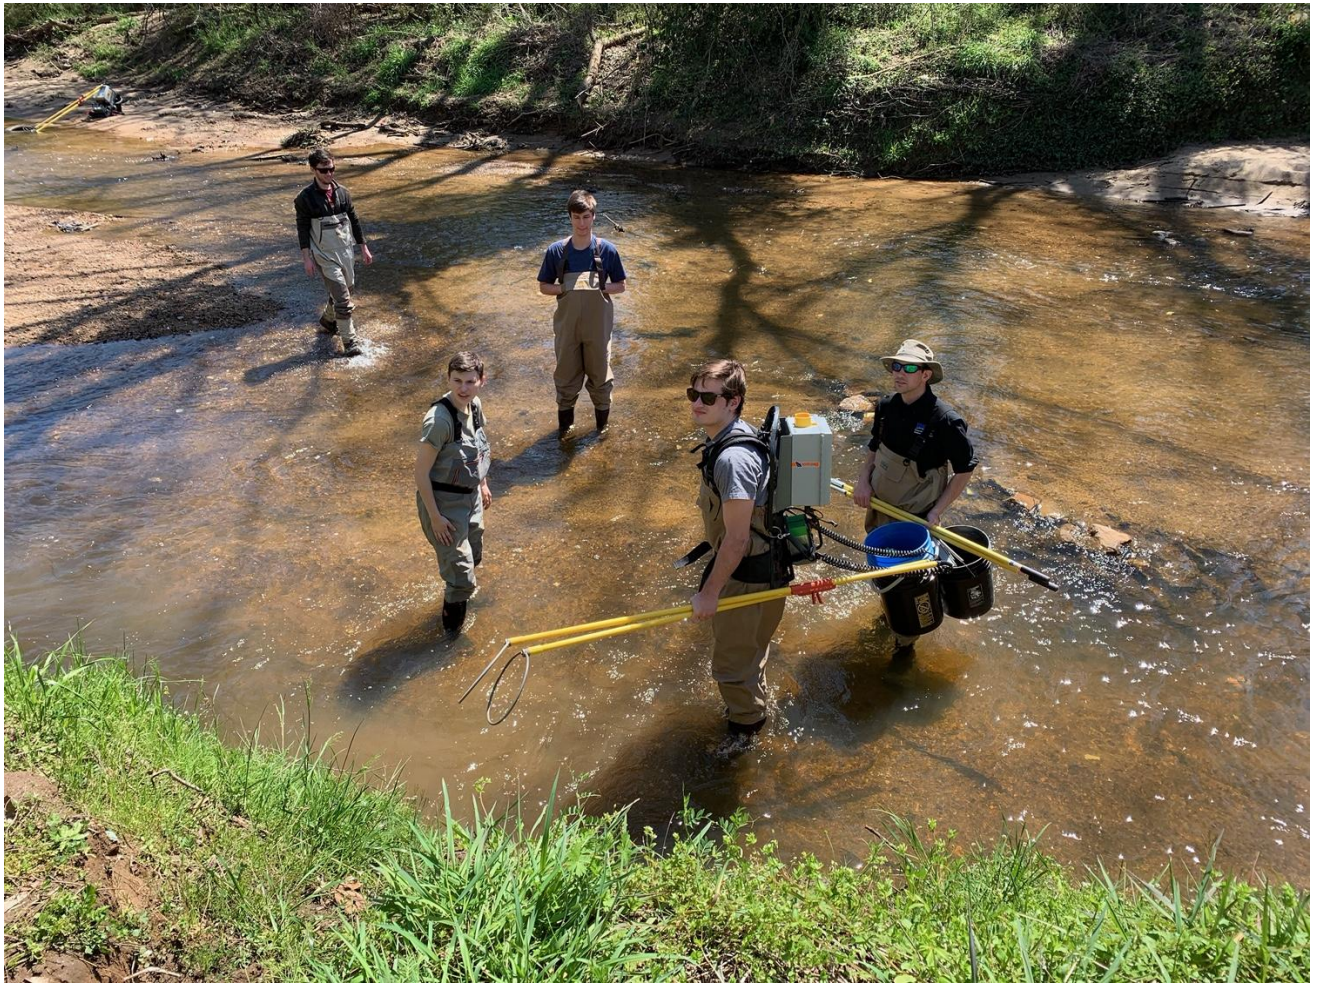
Figure E5. The Wildlife group demonstrating electrofishing methods in Walnut Creek.

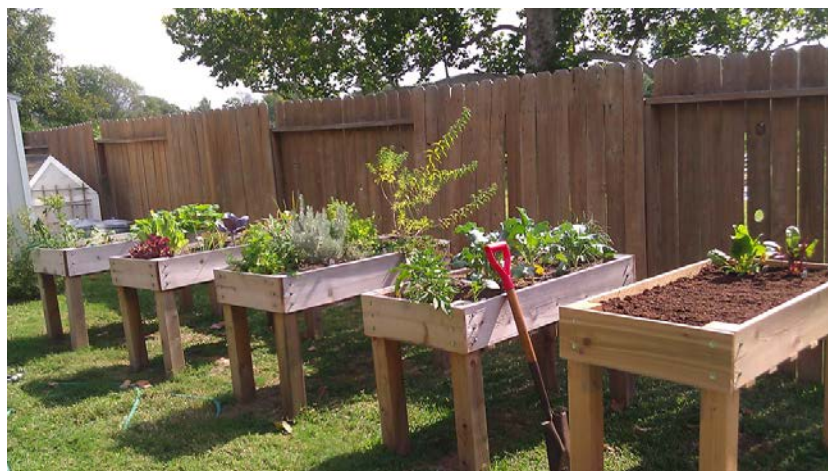
Figure 2.9. *Image of raised beds (Bravo, 2015).*

Use *Raised Beds*. Raised beds are the best option for the garden based upon the soil conditions in the proposed area and the desire to make the garden accessible to people who cannot bend or kneel down to the ground (Bravo 2015). Raised beds should be maximum 5 feet wide if they need to be reached from all sides; when one side is up against the wall the maximum should be 4 feet wide (Figure 2.9). The height for the raised beds should be 20 inches to 35 inches tall.

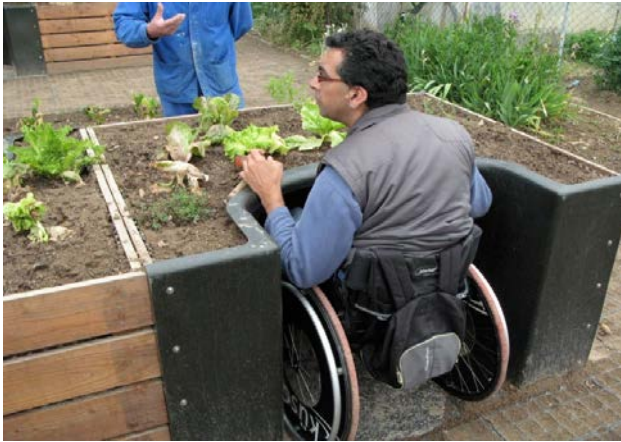
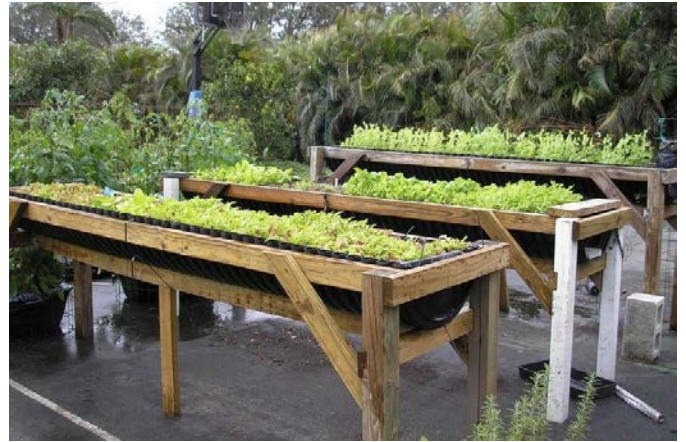
Figure 2.10. *Images of wheelchair accessible raised beds (Bravo 2015)*

The recommendations for wheelchair accessible beds are that each should be 5 feet wide, so they can be reached from all sides (Figure 2.10). The height of the beds should be 34 inches tall. This means the bed should start 27 inches up from the floor to include enough space for a wheelchair. This empty space for the wheelchair needs to extend 19 inches under the bed. The bed needs to have a height 7 inches of soil for the plants; making the overall height 34 inches (Bravo, 2015).

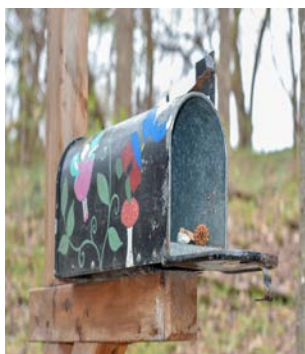
Figure 2.13. A “fairy mailbox” is similar to a “gnome home” where children are able to send and receive gifts from fairies. All of the items found in the park, encouraging engagement and imagination within children. The installment of a fairy garden will be a fun, low risk attraction that will be highly beneficial to children’s imagination and play.

The features found to be favorable and being recommended for use at Walnut Creek include a fairy mailbox, a bell tree, an intentional incline, a tree cookie art station, a fossil pit, a ball tunnel and stump steps (Figures 2.13-22).

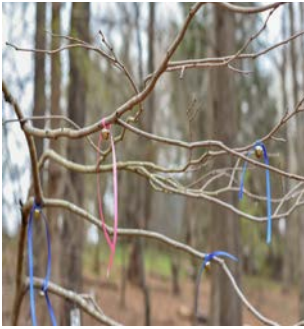
Figure 2.14. The bell tree is a simple tree that has bells tied onto it. When a child or strong breeze shakes the tree it makes sounds which engage a child's senses. The bell tree is a low risk attraction that allows sensory growth in children by listening and touching the tree.

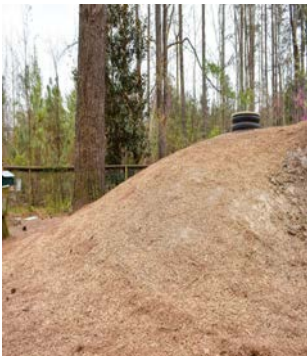
Figure 2.15. An intentional incline is essentially a few small hills made of excess soil. These can be strategically placed within the park to encourage children to use them as a means to get from one end of the nature play area to the next. It encourages children to work on their muscular growth as well as balance.

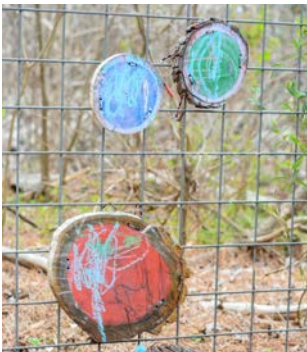
Figure 2.16. Tree cookies, slices from a fallen tree, can be used to draw on with chalk. The "cookies" are reusable and the chalk is able to be washed off intentionally or overtime by the rain. The cookie is a different medium than normal paper which stimulates more creativity and artistic thought.

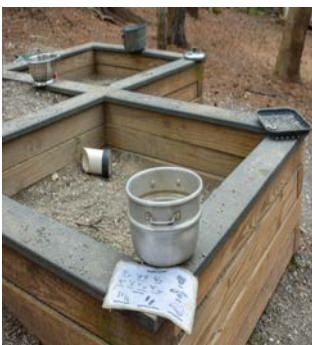
Figure 2.17. The fossil pit is a 4ft x 4ft pit lined by petrified wood and filled with a fossil mixture. This fossilized mixture includes fossils of insects, plants, shark teeth, aquatic vertebrates which can be obtained from a North Carolina mine that has a large amount of these fossils available to be picked up.

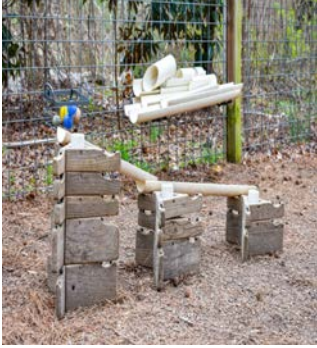
Figure 2.18. The ball tunnel is created with a split PVC pipe and several blocks that can be stacked to adjust height, which is one of the only unnatural pieces of equipment in the park. The pipes can be taken apart and put together to be designed as the child pleases, this will encourage problem solving and mental stimulation. The objective is to roll the ball down the ramp, and with different sized balls this will also help muscle building.

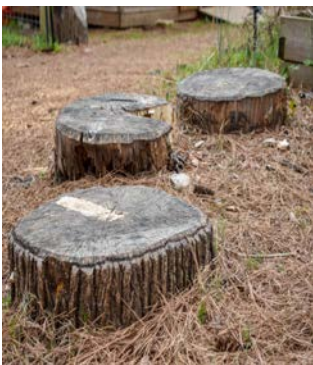
Figure 2.19. The stump steps are an item with minimal risk that are easy to design and maintain. The stump steps are small slices of fallen trees of differing heights that can help to build muscles, balance and foot eye coordination. These stumps allow children to hop from one spot to the next while changing the height and distance between steps.

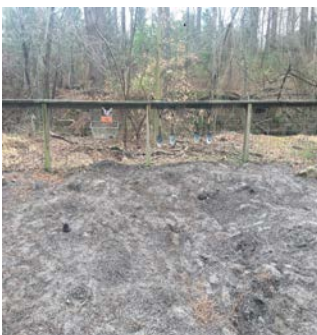
Figure 2.20. The dig pit is a large area, that has been emptied and filled with a sand/soil mix and will be accompanied with small shovels to allow children to engage in physical activity while using creativity. This is slightly dangerous as the children would be able to accidentally or intentionally injure each other with shovels or sand. This would also offer only slightly different benefits than the fossil dig pit, which has slightly less risk associated with it due to the nature of its set up and the materials used with it.

There are three additional features we recommend tentatively, because they have a slightly higher risk. These features include a dig pit, music area and balance beams.

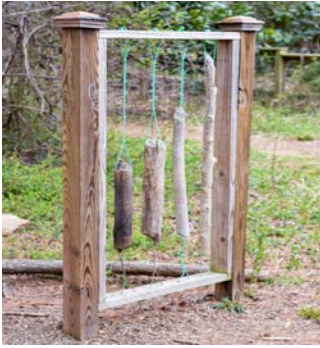
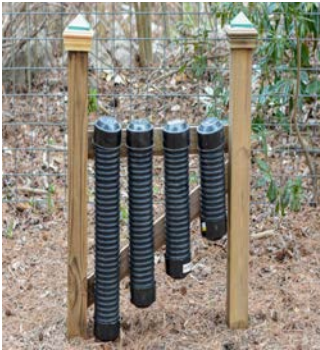
Figure 2.21. A “music area” is comprised of a series of natural materials such as wood which is strung from a wooden frame. Children can make music with this by hitting the materials with different naturally made “drumsticks”. This is a beneficial piece of a nature play space due to the collaboration children can have with each other and the sensory stimulation that this allows. This is also, however, something that could allow children to injure themselves and others, due to the nature drumsticks as well as the rope and other equipment used in its construction. Though it is a beneficial feature, the risks of it could potentially be high and therefore more consideration must be made by park workers before it is used at Walnut Creek.

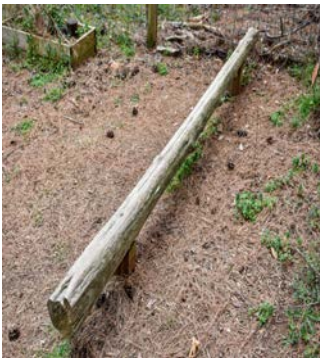
Figure 2.22. Balance beams are constructed using falling logs, which are situated to encourage children to improve their balance, coordination and cooperation with other children. Injuries from this are possible and the risk associated is moderate, as children are capable of falling from it and getting cuts, scrapes and bruises. This means that there is a fairly high risk and it may not be acceptable.

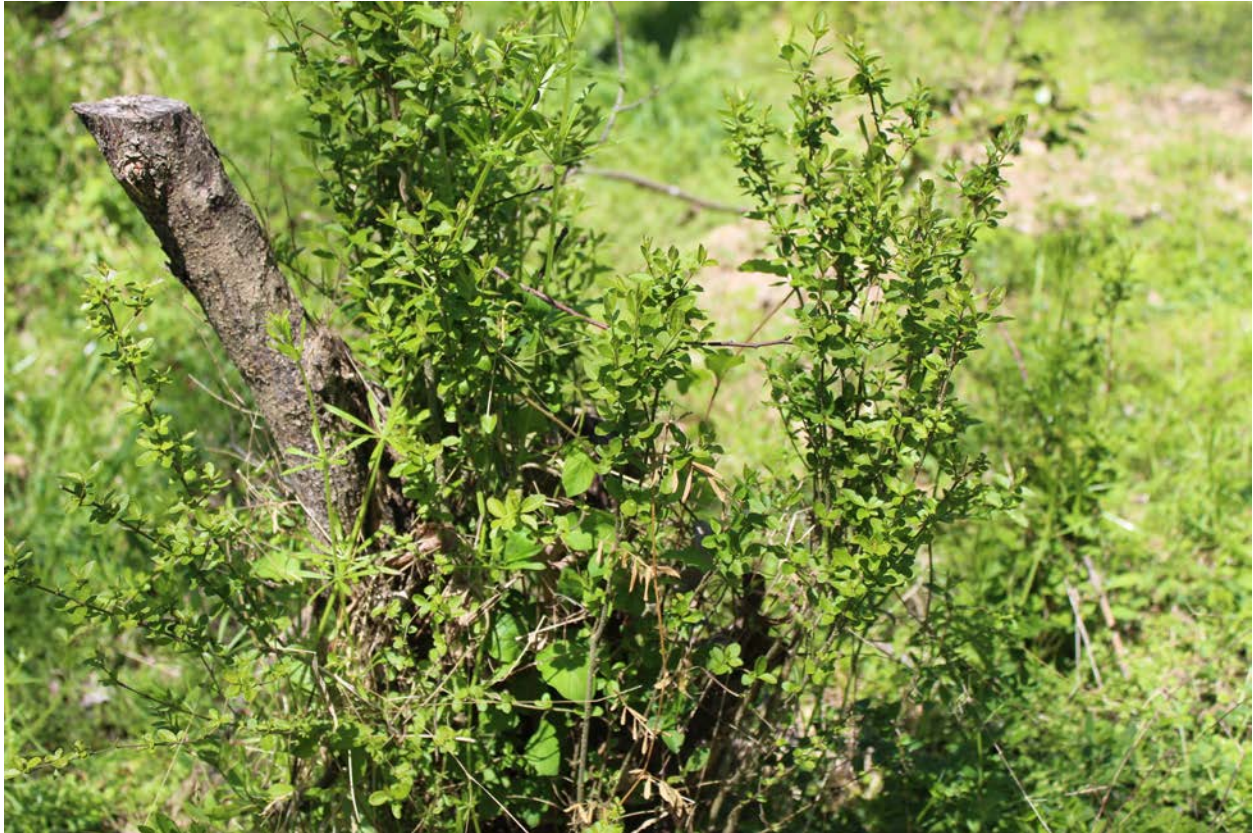
Figure 3.5. *A privet stump sporting new growth.*

If adult privet is cut at the stump, it will not perish, but rather survive and continue to create new growth (Figure 3.5). It must be continually cut back whenever new growth appears and eventually it will wither and die. Cutting back adult privet with a saw and keeping an eye on new growth for several years would be a much less physically intensive task, but more time consuming than removing all of the root bases at once (Bryan England, personal contact). It is at the discretion of the wetland center which path to take. Another thing that must be dealt with is the juvenile privet stalks, which can be found throughout the park. These must be pulled whenever found, otherwise if allowed to grow they can become too much for a single person to deal with. Due to the influx of seeds from upstream sources, young privet will continually pop up around the wetland, and as a result will need to be continually watched for. In addition, because adult privet has been allowed to flower throughout the park for years, young privet shrubs will

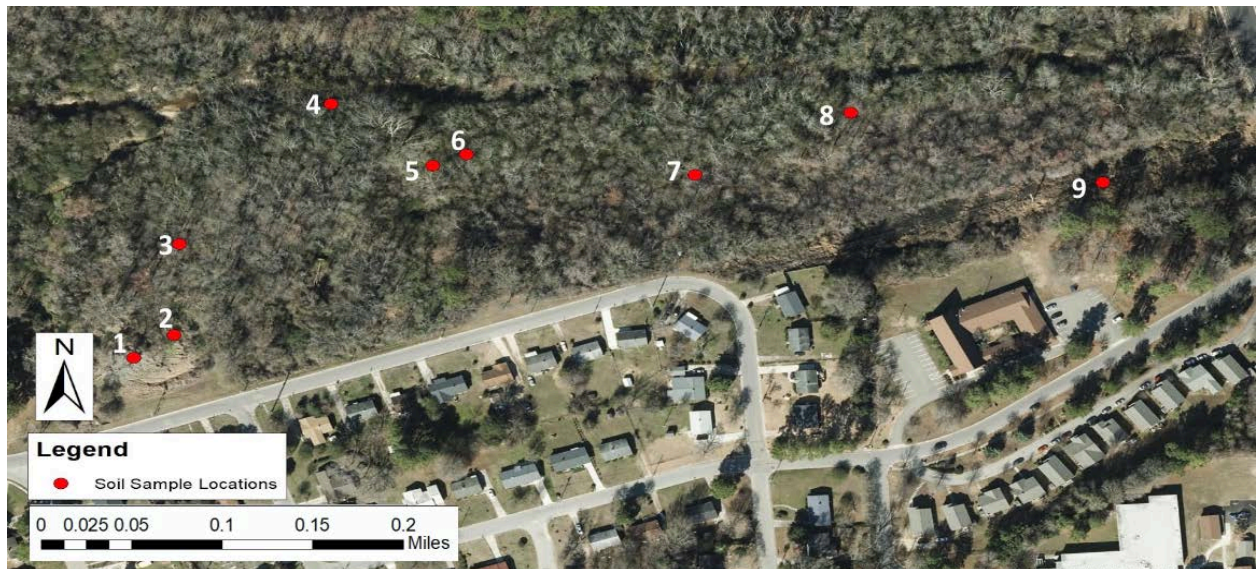
Figure 5.3. *This map indicates the locations of our soil samples.*

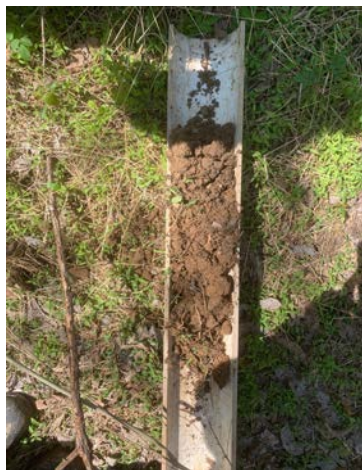
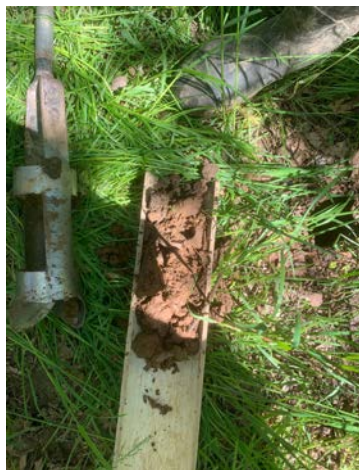
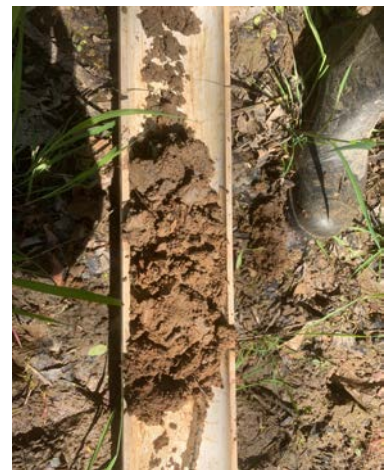
Figure 5.4. *These photos show the soil conditions at three of our sampling sites. We dug until we found standing water, so that is why the samples extend to different depths. All of the nine sampled sites fall within a moisture range represented by these three sites.*

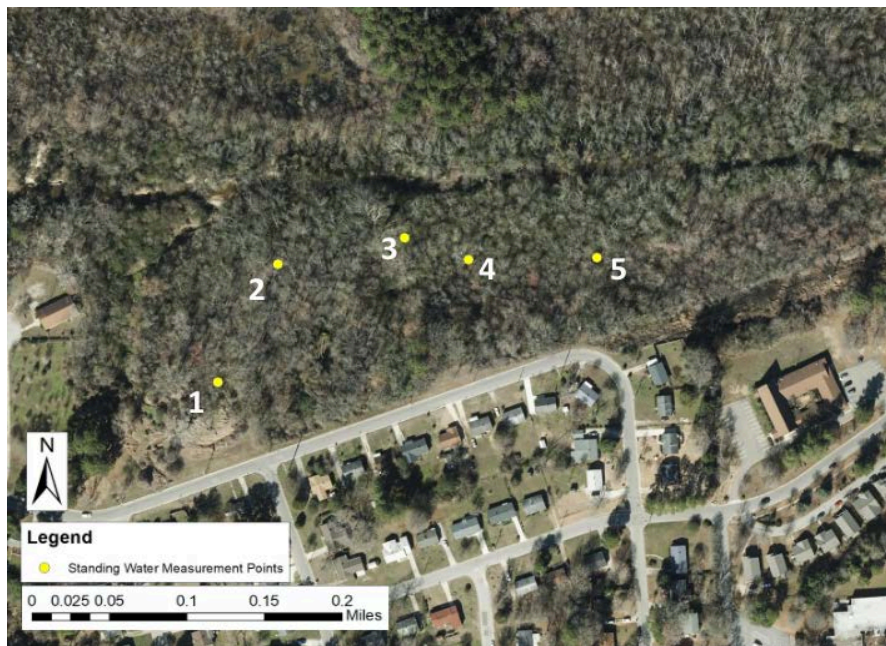
Figure 5.5. *The sites of standing water sampling can be seen here. These sites correspond with the general area of our potential paths.*

The water level measurements were taken to observe the effect that rainfall had on different sites along the potential pathways. The water level measurements were taken at five locations along the potential pathways (Figure 5.5.) Not surprisingly, we found that standing water levels were much higher after periods of rainfall, but even during week long periods where rainfall only totaled 0.01 inches (March 13-March 20), standing water still persisted in some areas (Figure 5.6.) Site three consistently had standing water, and this information will be helpful in determining if a path should be placed here. This also tells us that in the event of pathway construction crossing this site, a flood tolerant material would be needed.

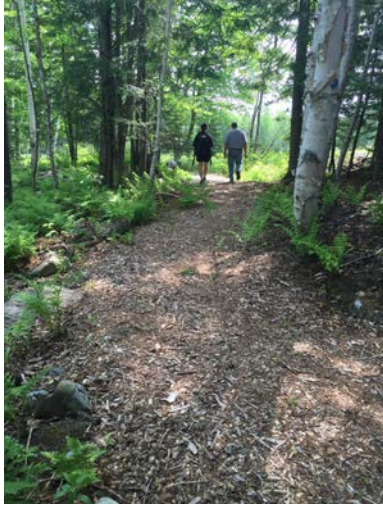
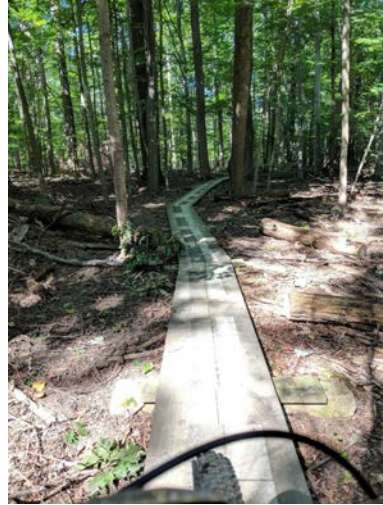
Figure 5.7. *The photo on the left shows the type of mulch pathway we are proposing (image from MaineTrailFinder.com). The photo on the right shows a simple wooden pathway in Strongsville, OH that we are using as a model for our suggested boardwalk (image from AllTrails.com).*

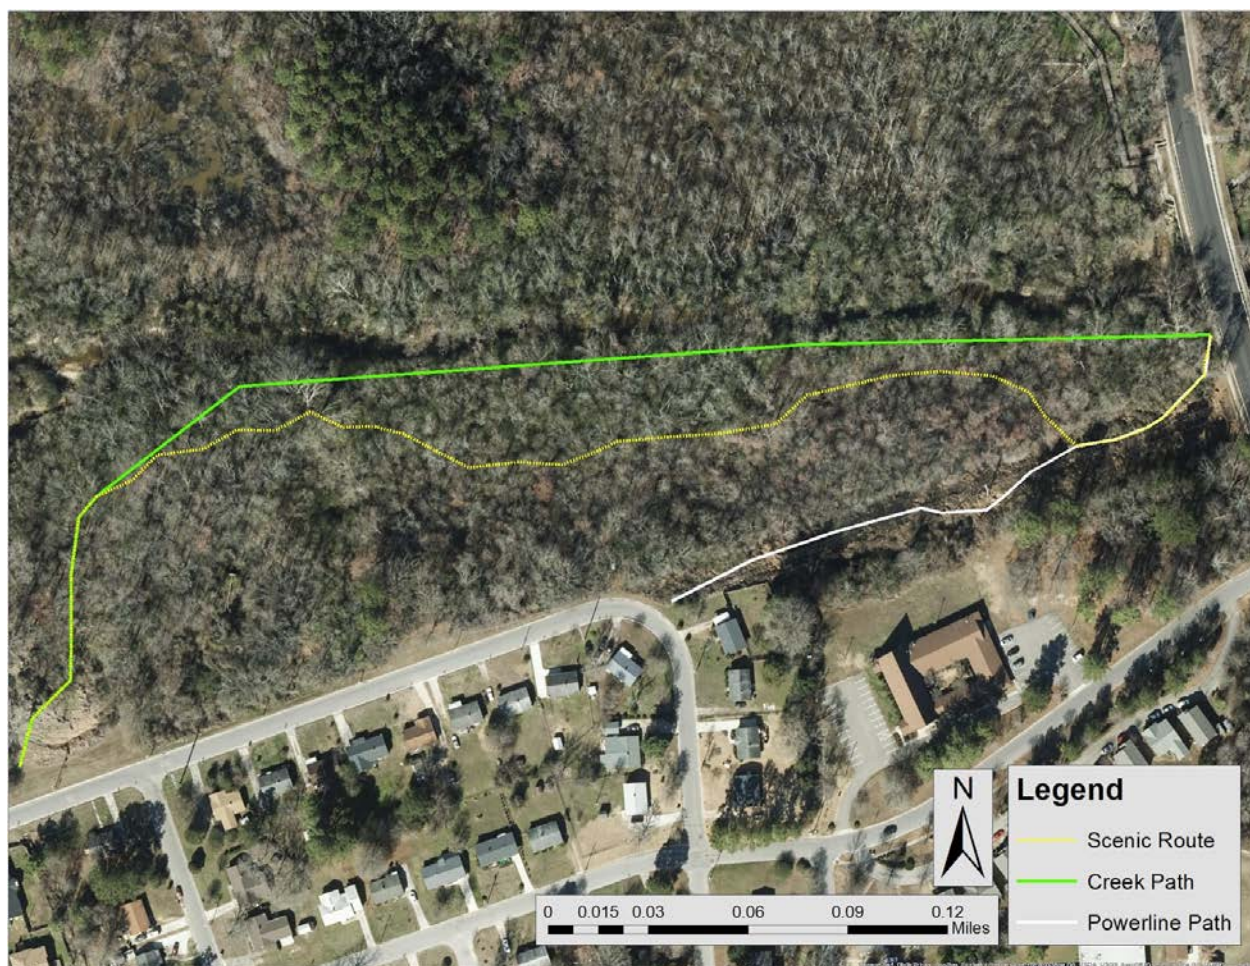
Figure 5.8. *Our three potential pathway routes can be seen here.*

Based on our examination of site conditions, we propose three possible trail routes (Figure 5.8). While not all of the paths begin at the same location, they all end at State Street. The ending point is at the bridge over Walnut Creek; this location was chosen because it is where the presence of guardrail begins, which would provide a safer trail exit. This area is uphill, so the construction of a simple wooden staircase would be required.

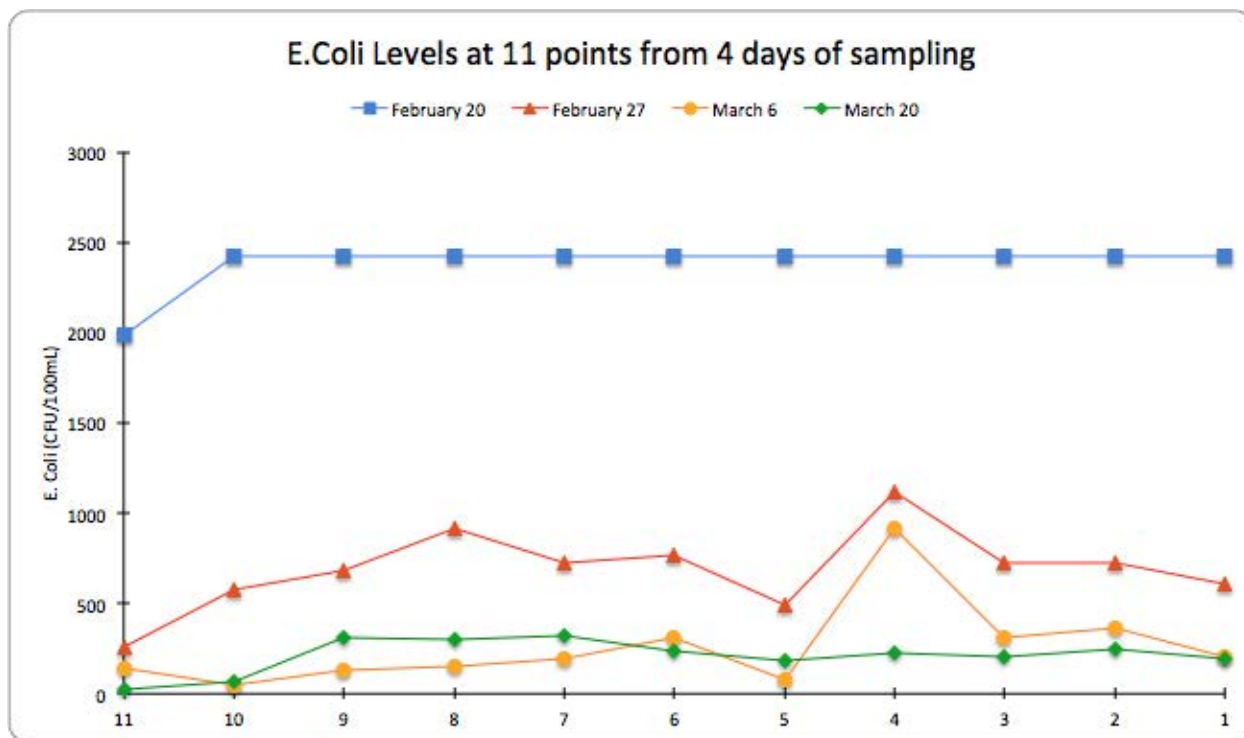
Figure 4.2. *E. coli* data displaying the sample date, the point of sampling, and the measurement in CFU/100mL. The stream flows from left to right along the x-axis with major inflows at points 10, 9, & 4.

Our *E. coli* data varied a lot depending on the day of sampling. Our first two days of sampling, February 20th and 27th were both higher than is recommended for Class C recreational waters. We believe it is likely the data varied based on how close it was to a rain event. The day before our February 20th sampling was a very heavy rain event, which elevated the levels of *E. coli*. Many of the results showed *E. coli* levels greater than 2,420 CFU/100mL, which is the maximum our sampling equipment would allow us to measure.

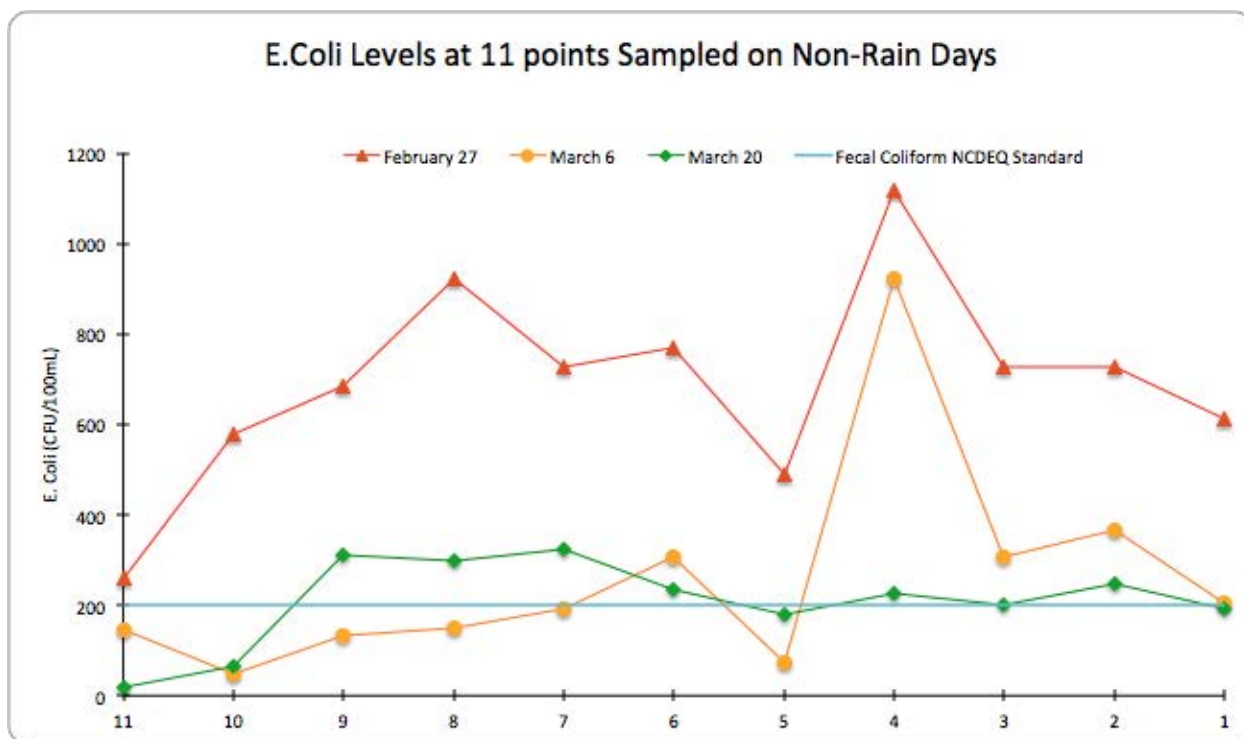
Figure 4.3. *E. coli* data excluding our first day of sampling, February 20th which was our only significant rain event throughout the study period. The stream flows from left to right along the x-axis with major inflows at points 10, 9, & 4.

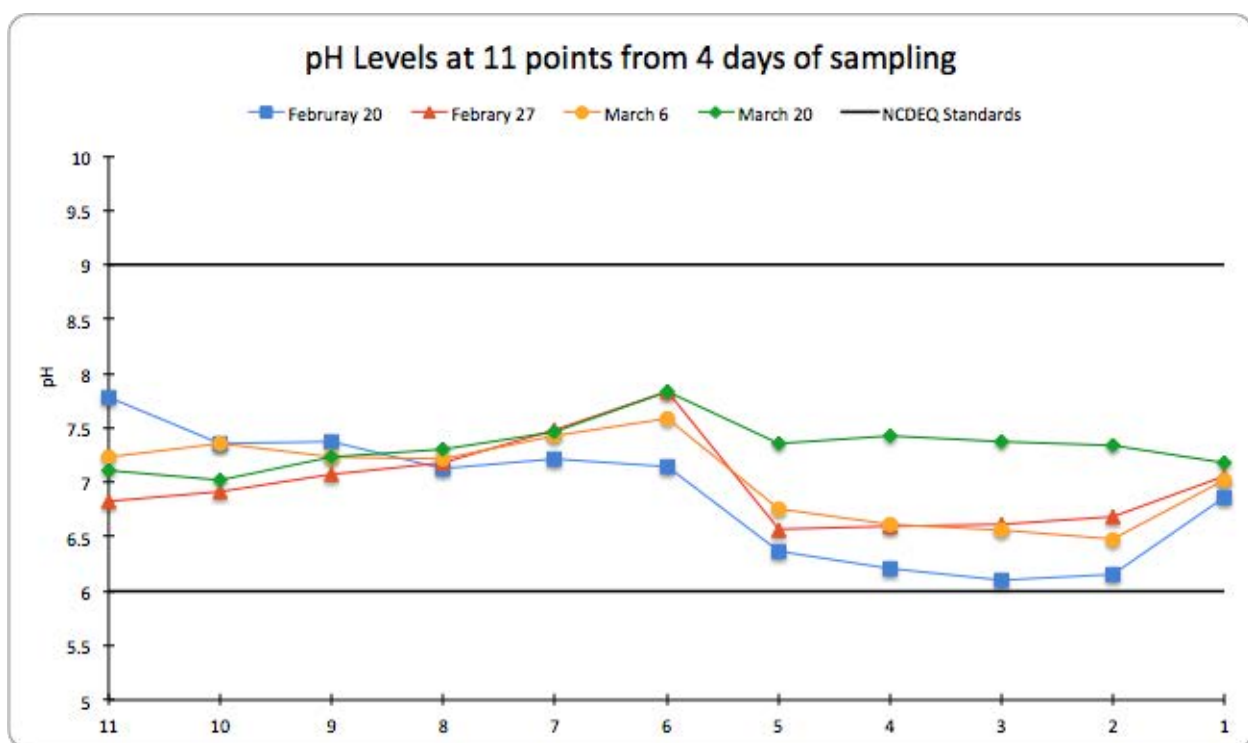
Figure 4.4: Chart of pH measurements as well as NCDEQ standards for Class C waters. The stream flows from left to right along the x-axis with major inflows at points 10, 9, & 4.

pH Levels Healthy. pH is the measure of hydrogen ion concentration in a solution. pH can only be measured if there is water in the solution, with that being said, it measures how acidic or basic a solution is (Helmenstine 2019). pH, along with many other parameters, is a way to determine the health of a stream. All of our monitoring data was close to neutral ranging between 6 and 8 (Figure 4.4). NCDEQ standards recommend that for Class C waters pH should be between 6 and 9 (Surface Water Quality Standards).

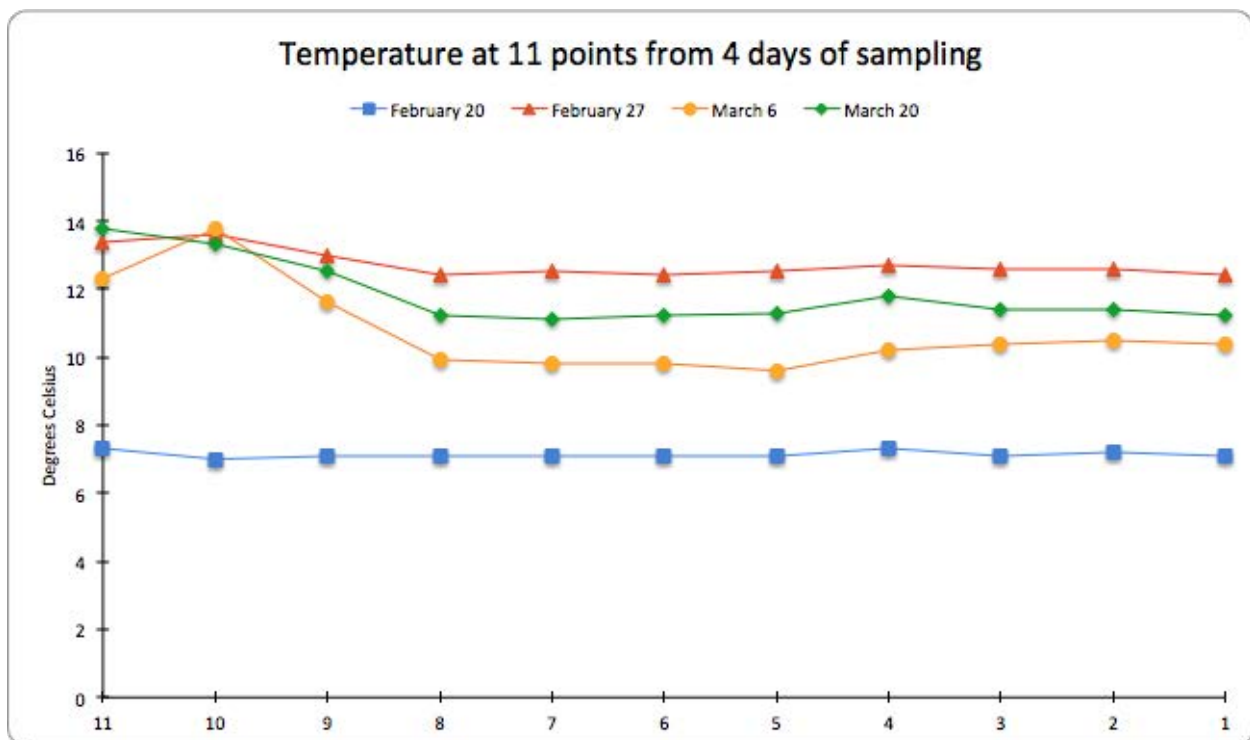
Figure 4.5. Chart of temperature measurements for our four sampling days. The stream flows from left to right along the x-axis with major inflows at points 10, 9, & 4.

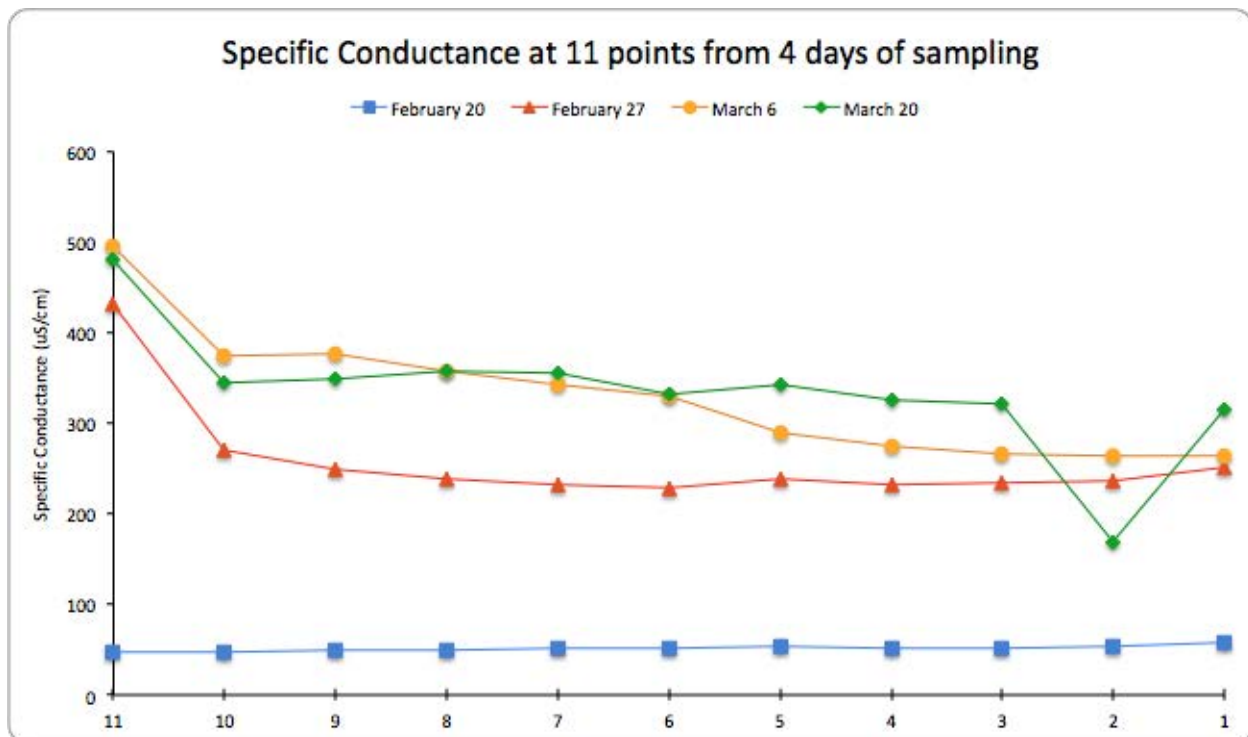
Figure 4.7. Chart of specific conductance measurements for all sample locations and dates. The stream flows from left to right along the x-axis with major inflows at points 10, 9, & 4.

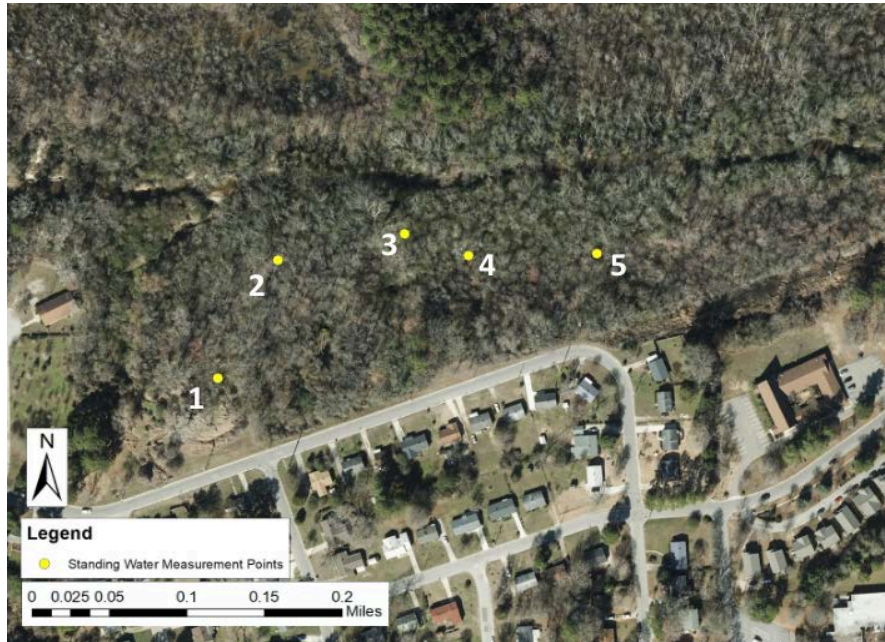
Figure 7.4.2. *This map depicts the sites of standing water level measurements. They were chosen along some of the more saturated areas of this region to assess how flooded the topography can become after rainfall events.*

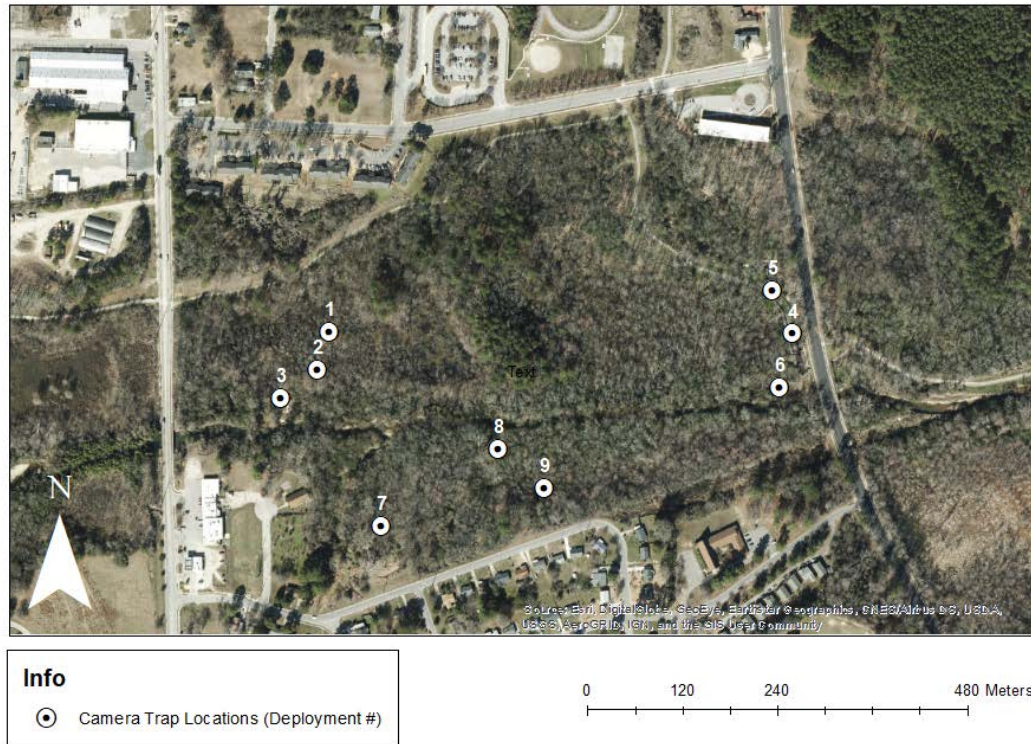
Figure 7.5.1: *Camera Trap Deployment Location Map*

* Deployment 3 was replaced by deployment 10 at the same location

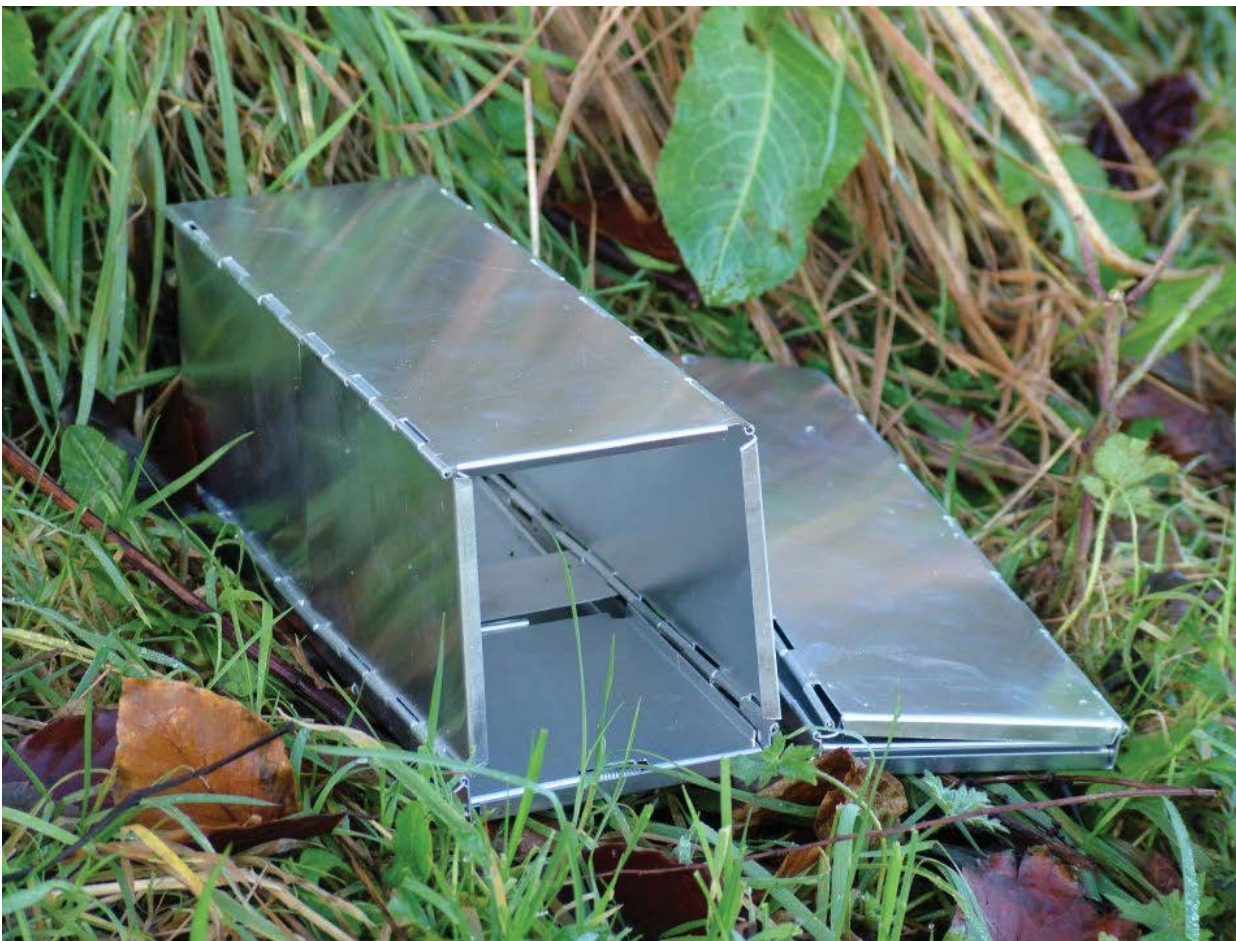
Figure 7.5.2. *Sherman live trap* (<https://www.shermantraps.com/>
<https://www.nhbs.com/sherman-trap-small-folding-aluminium>).

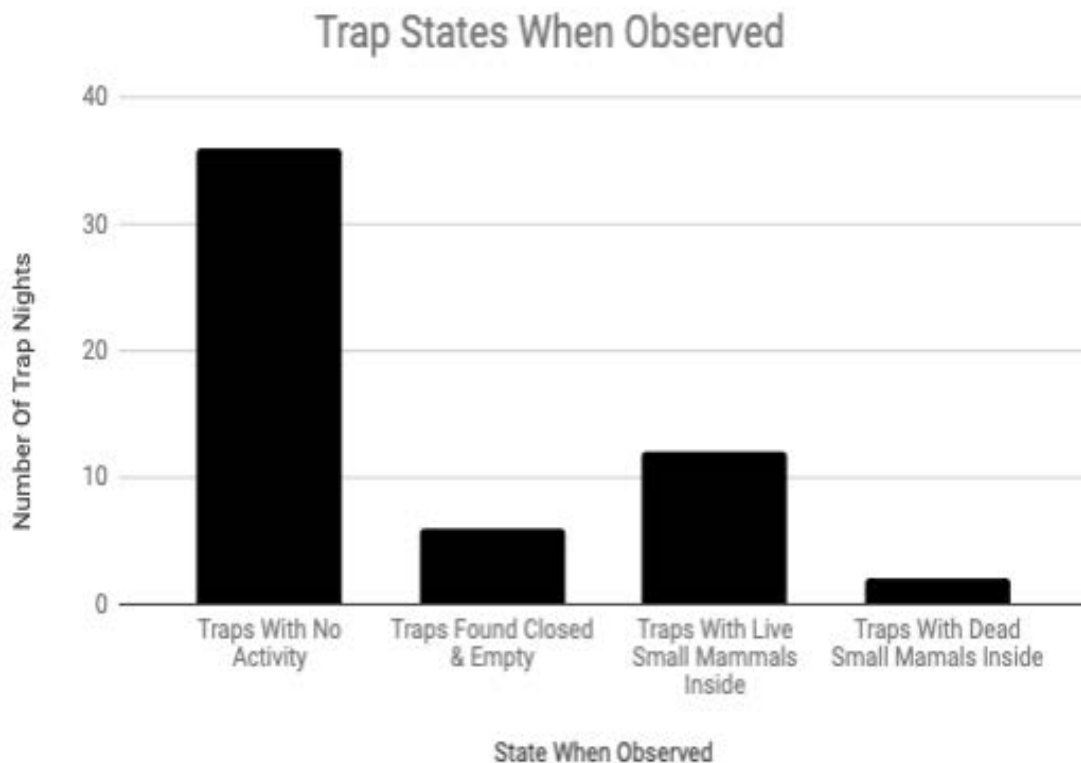
Figure 7.5.3. Sherman trap states when observed. Cumulative observations after five nights of trapping.
